Front (north) façade as seen from Main Street (Spring 2025)

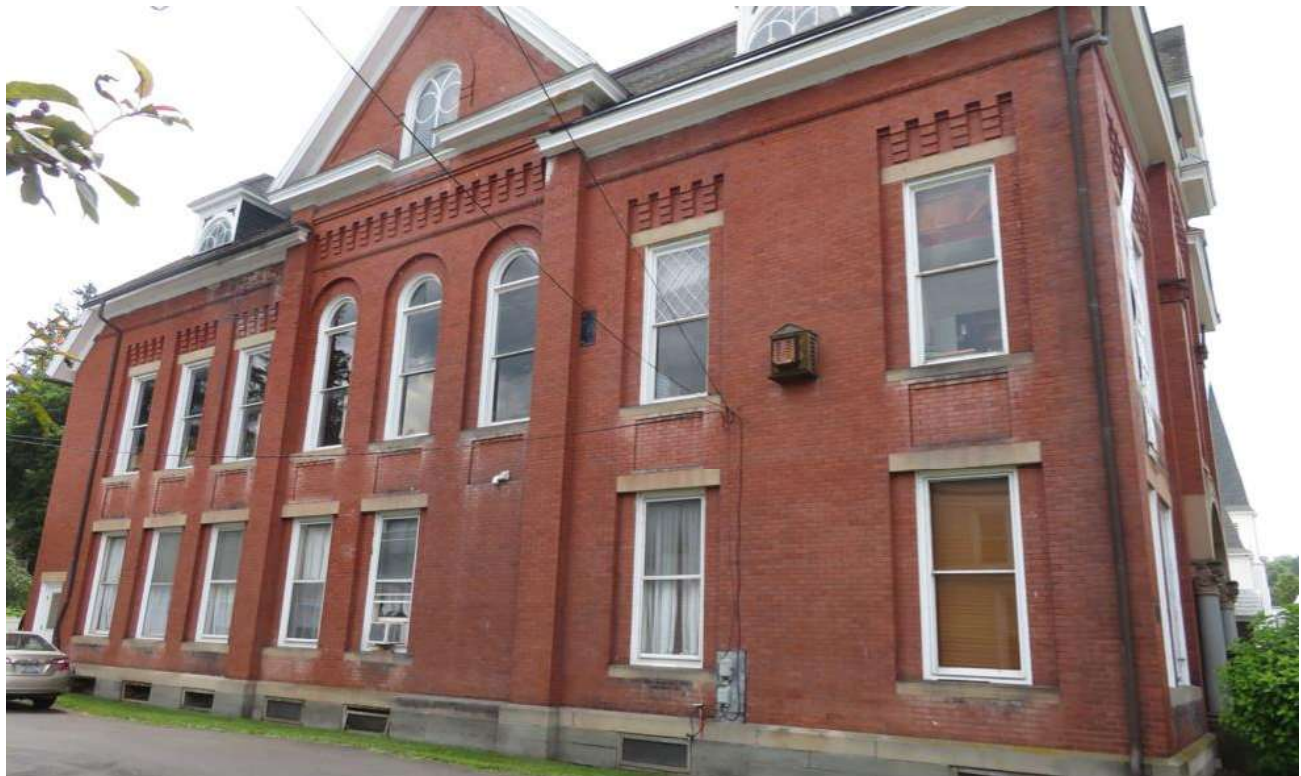
East façade as seen from Main Street

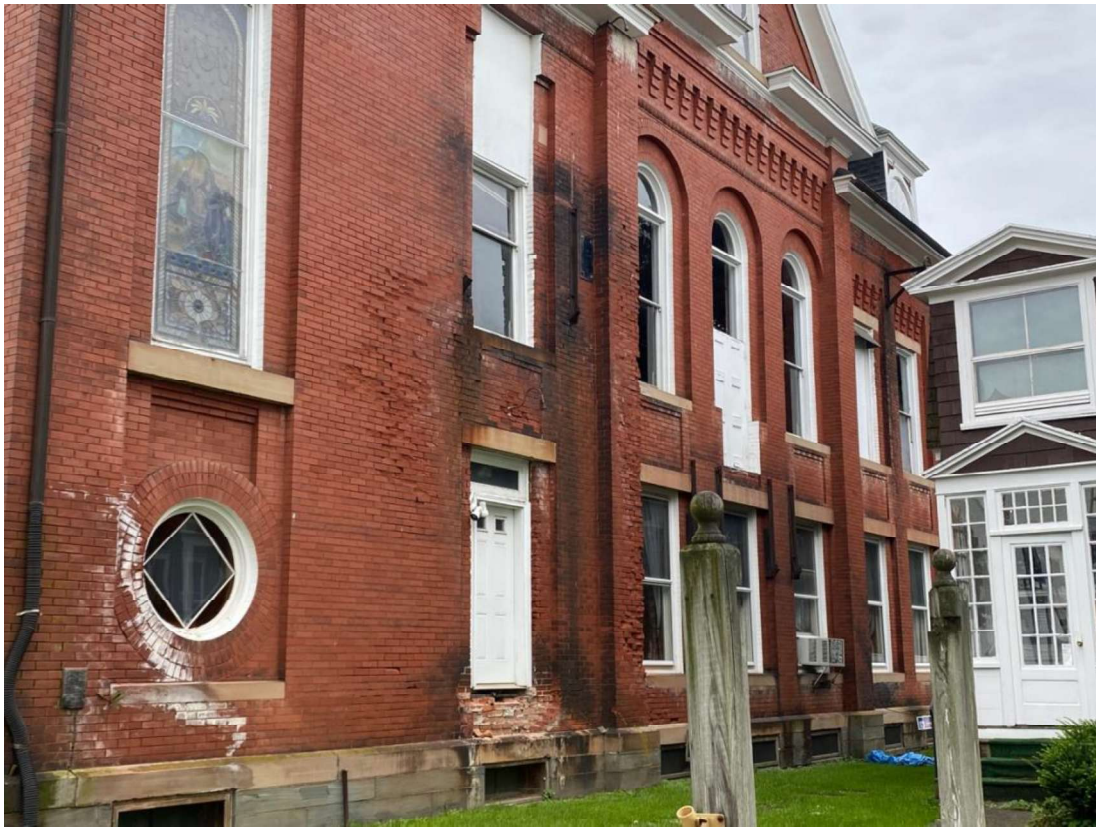
West façade showing masonry deterioration and altered fenestration

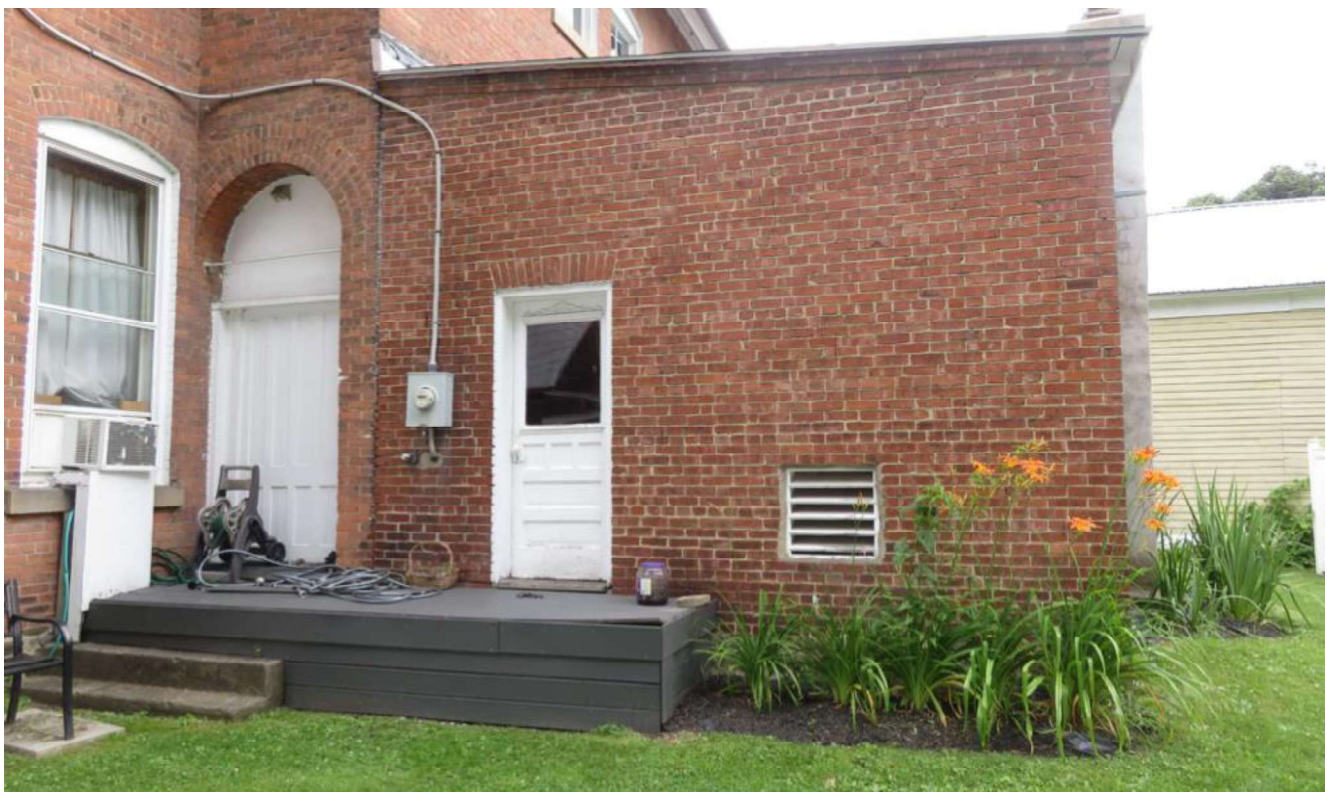
Rear addition showing deteriorated porch and door.

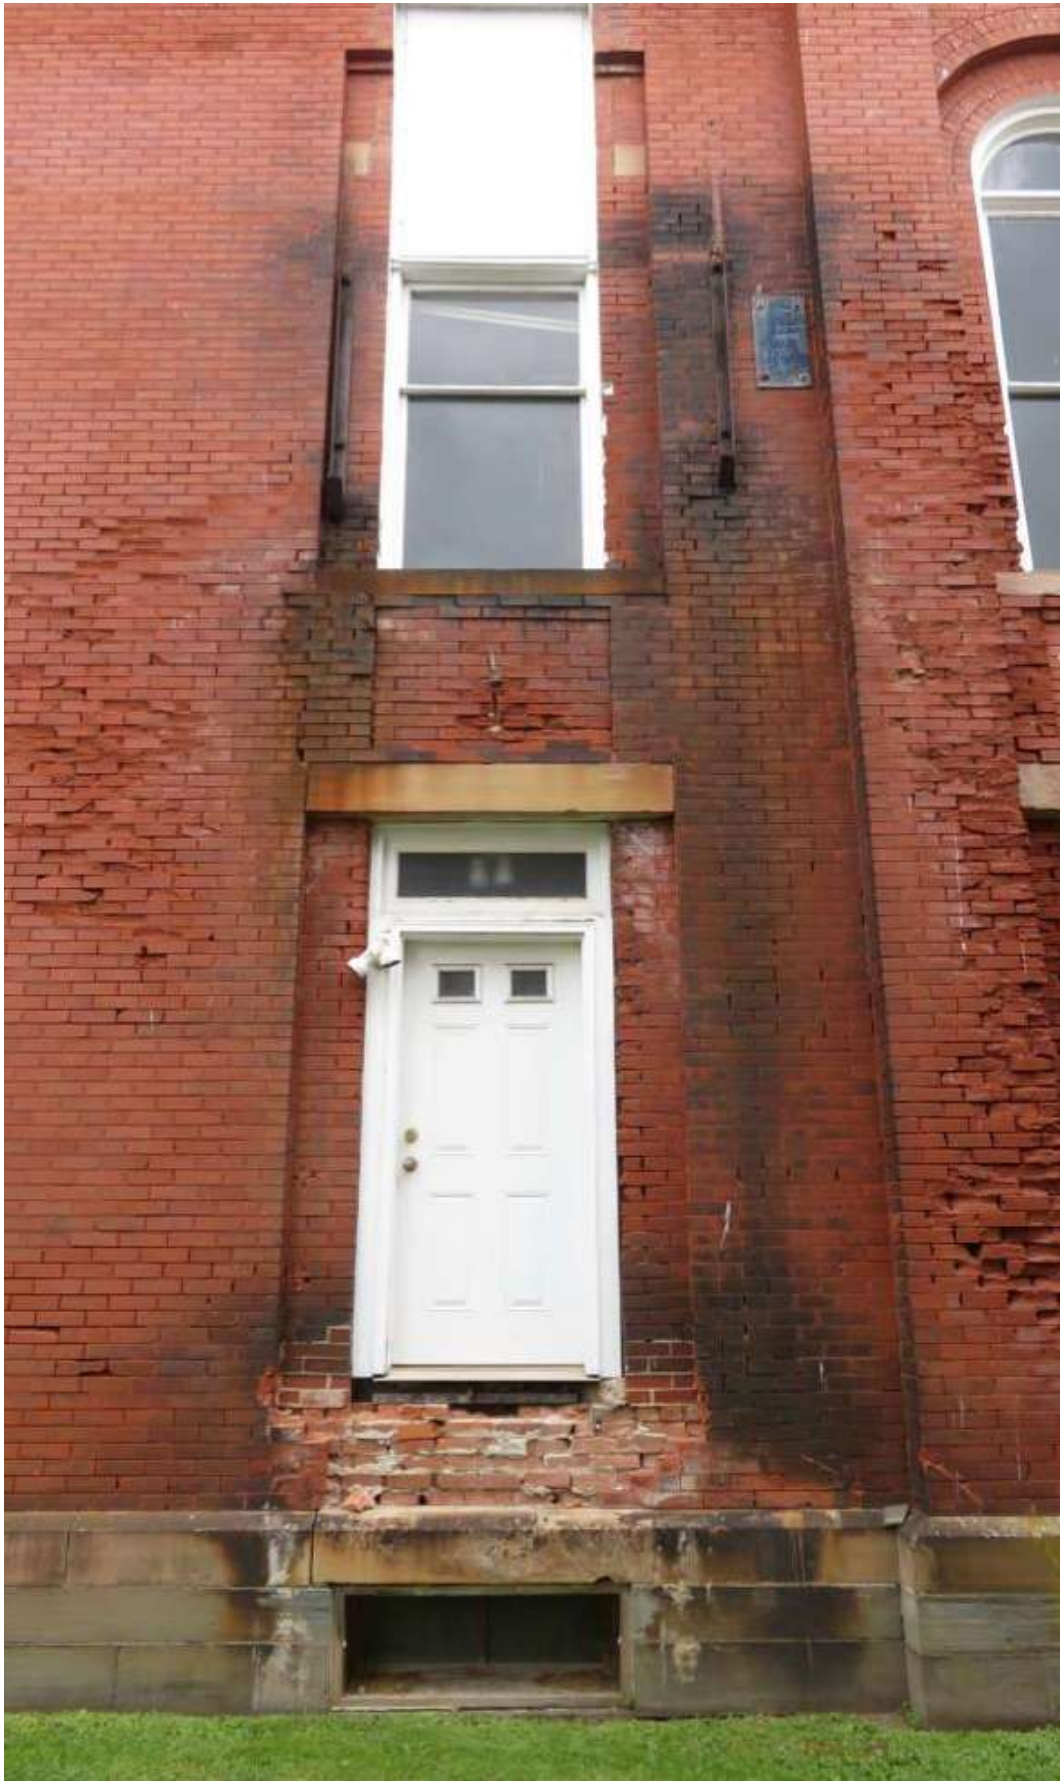
West wall showing severe brick deterioration and altered window openings

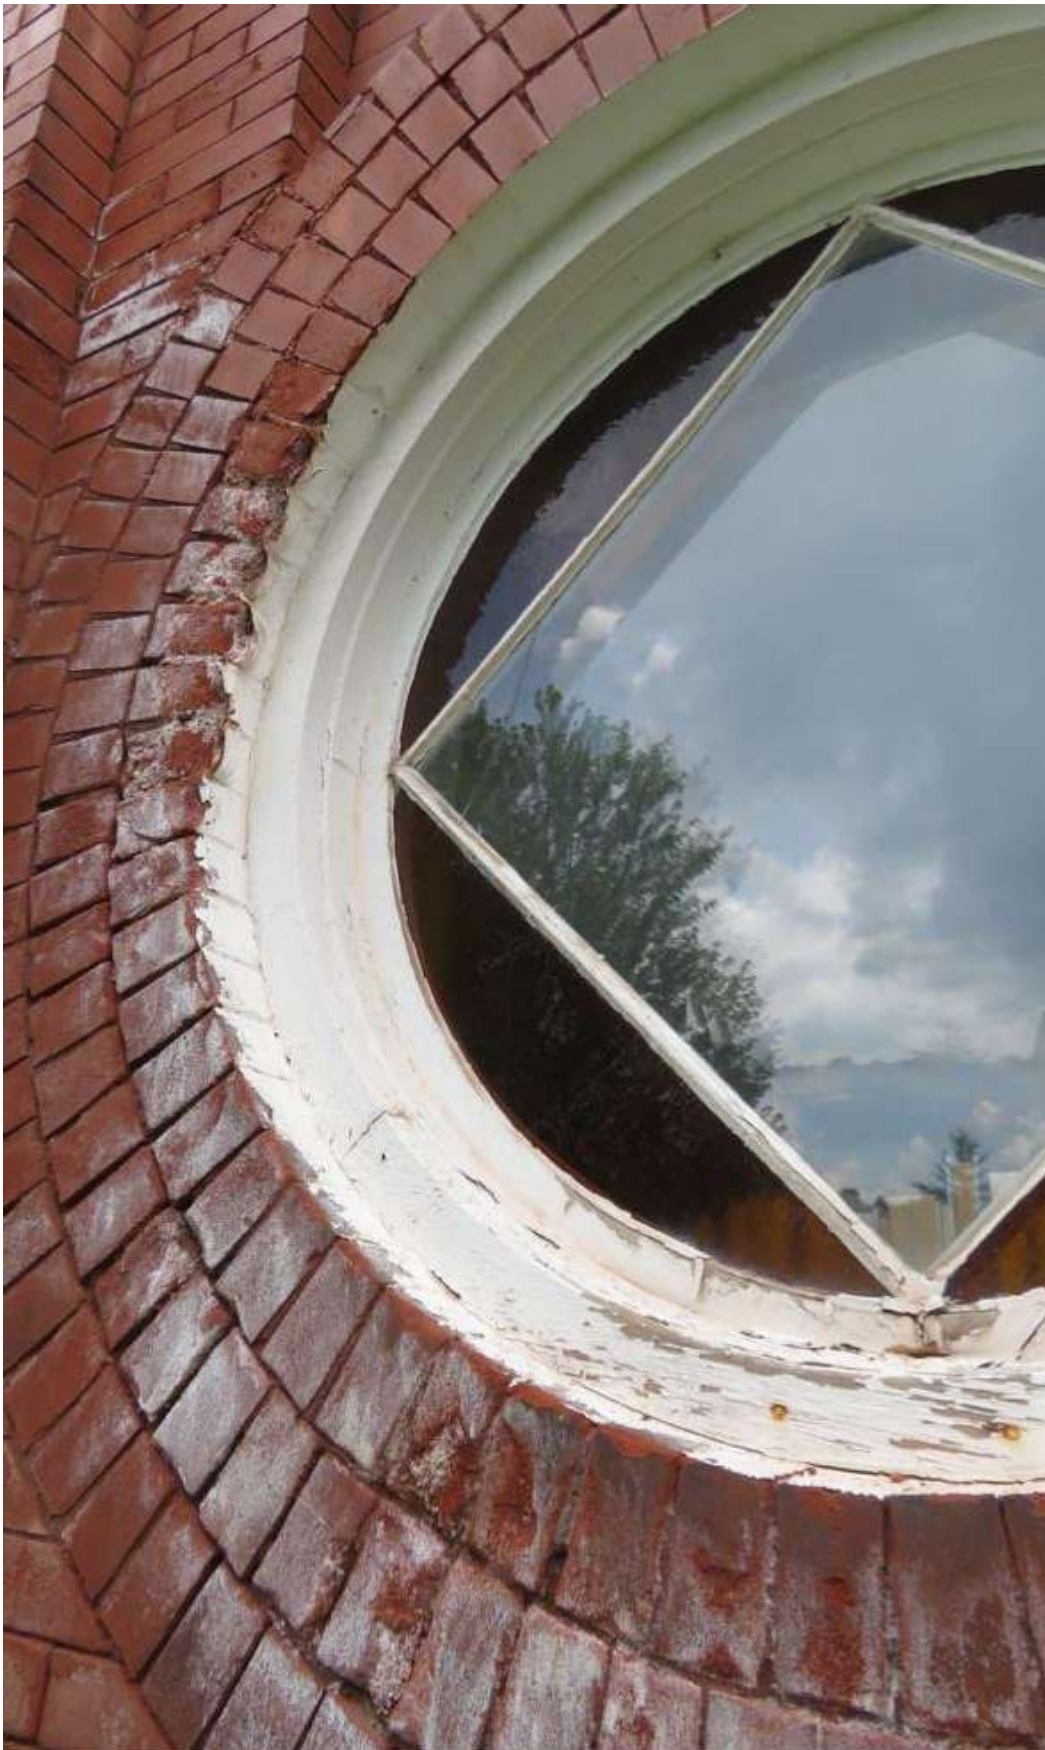
Effloresces, spalled brick, overpainted brick and deteriorated wood

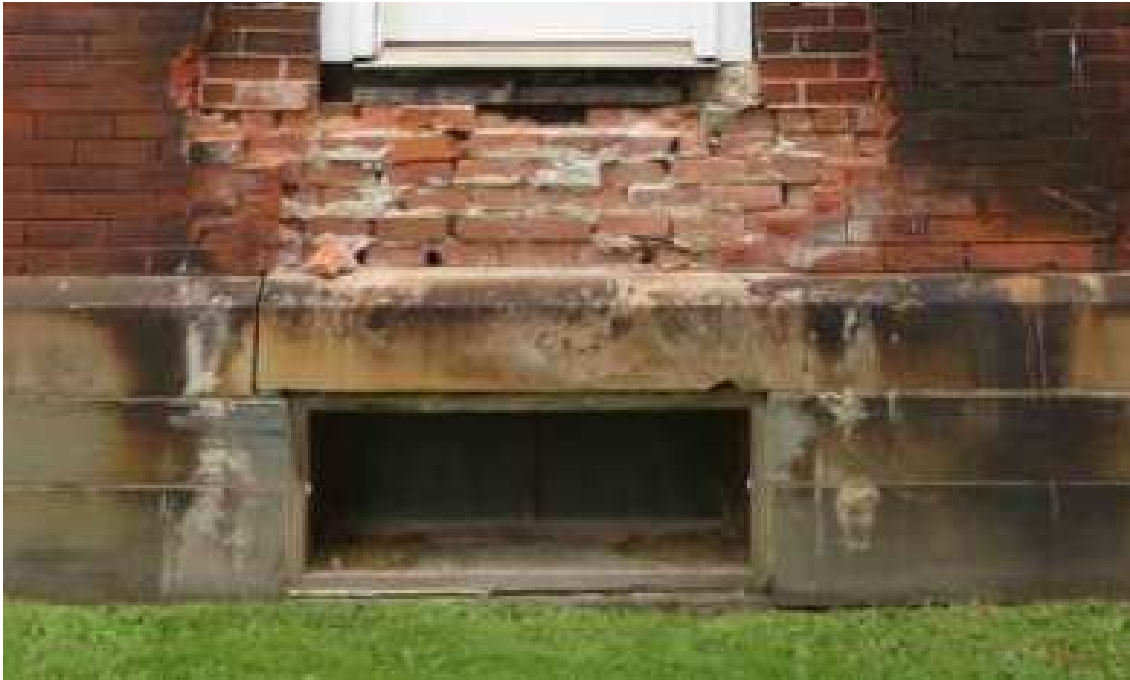
Failing masonry on west wall and basement window

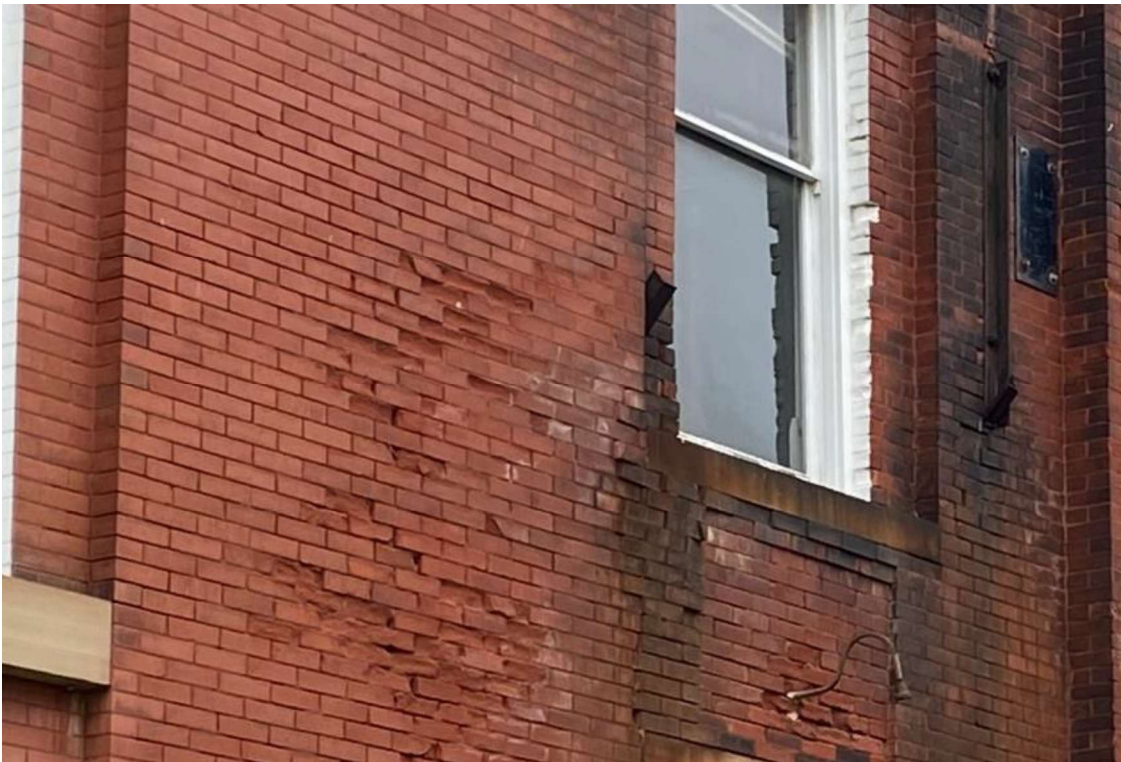
Spalled and damaged masonry on west wall

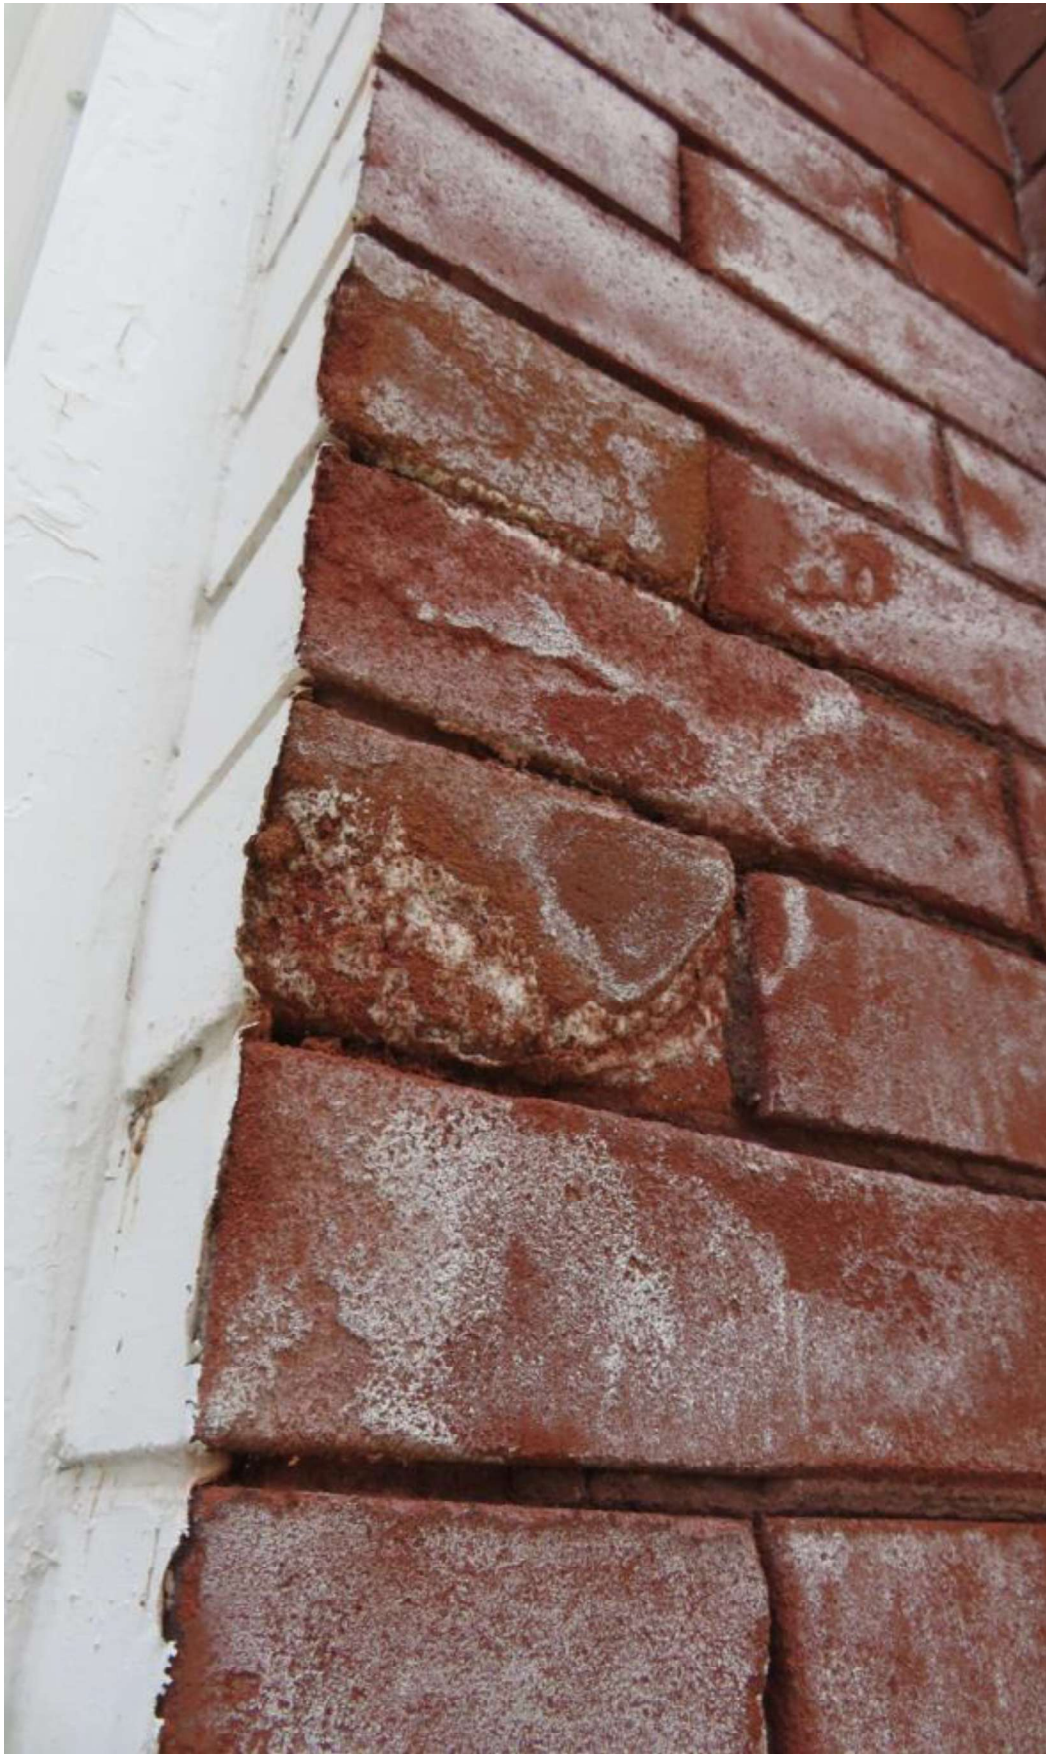
Closeup of window opening showing water damage and overpainting

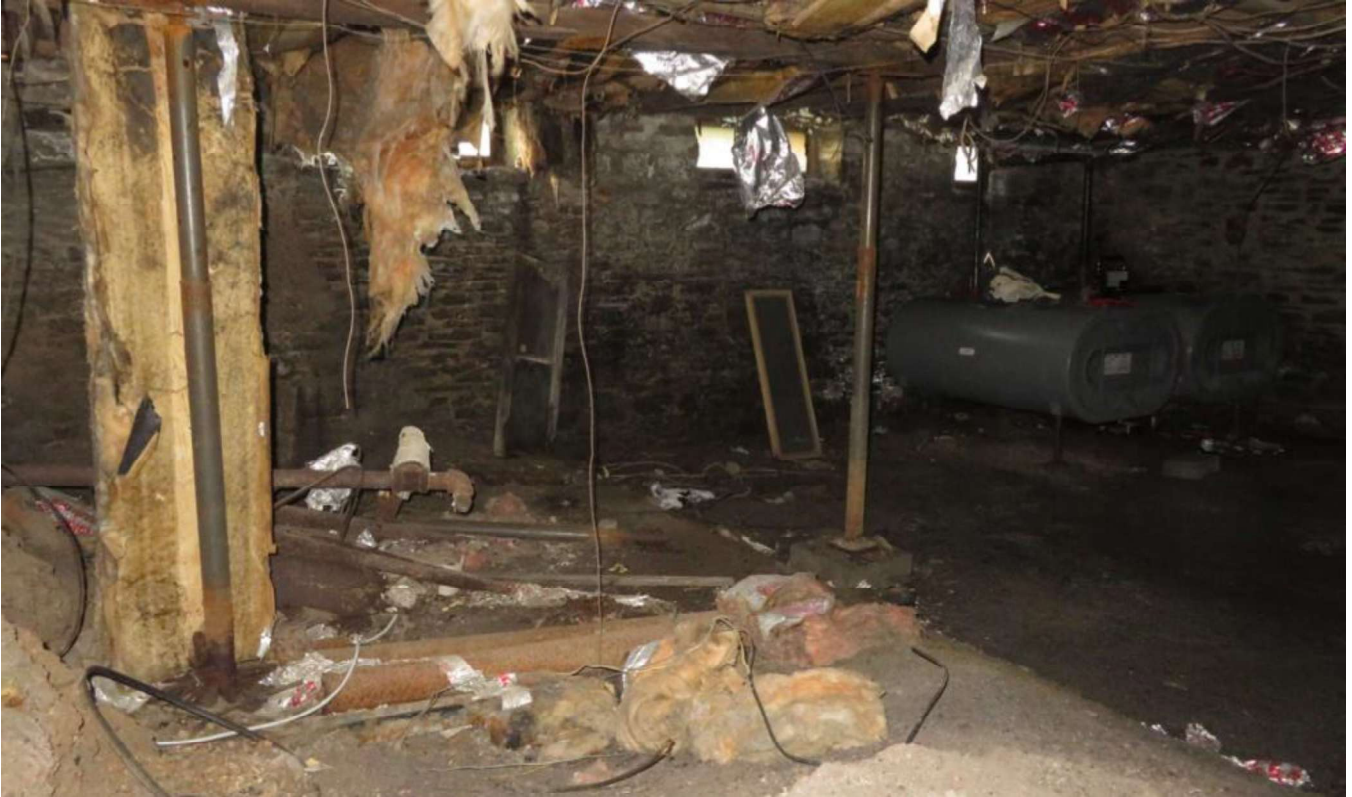
Basement with dirt floor has high moisture levels causing deterioration

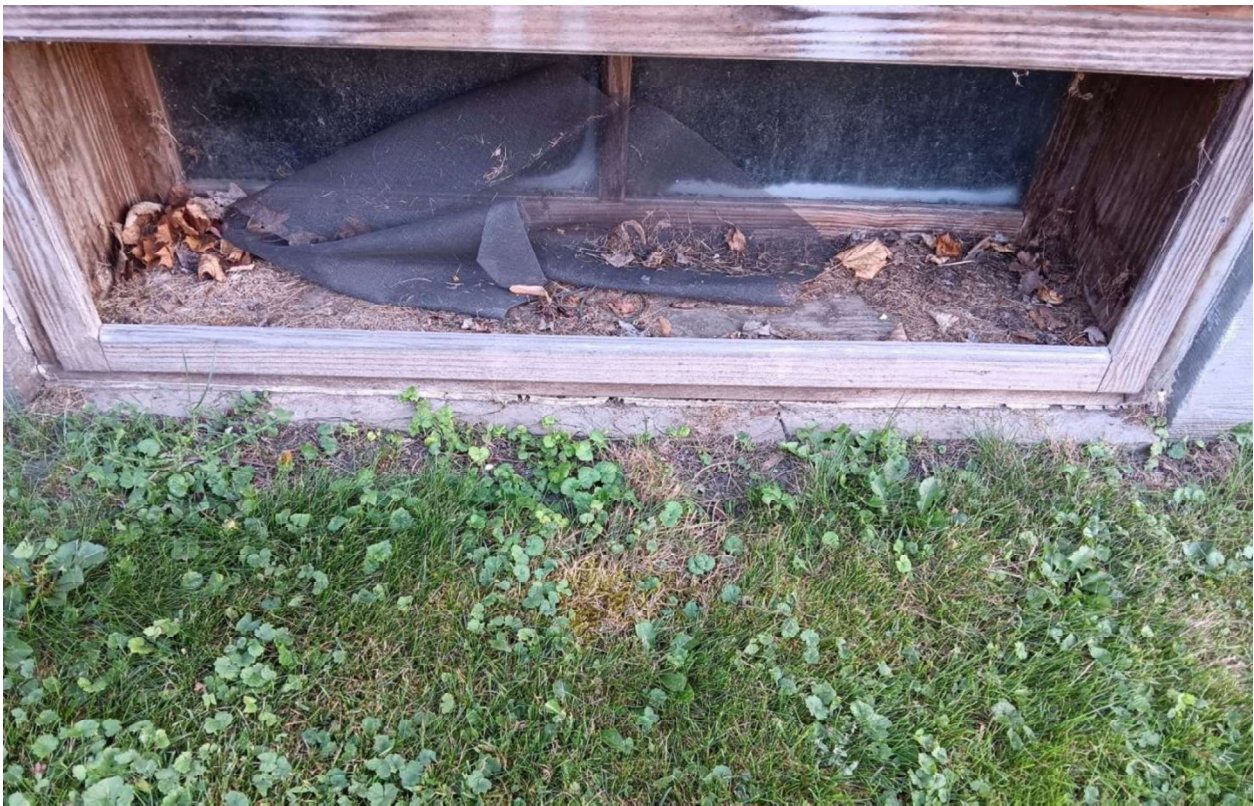
Typical basement window

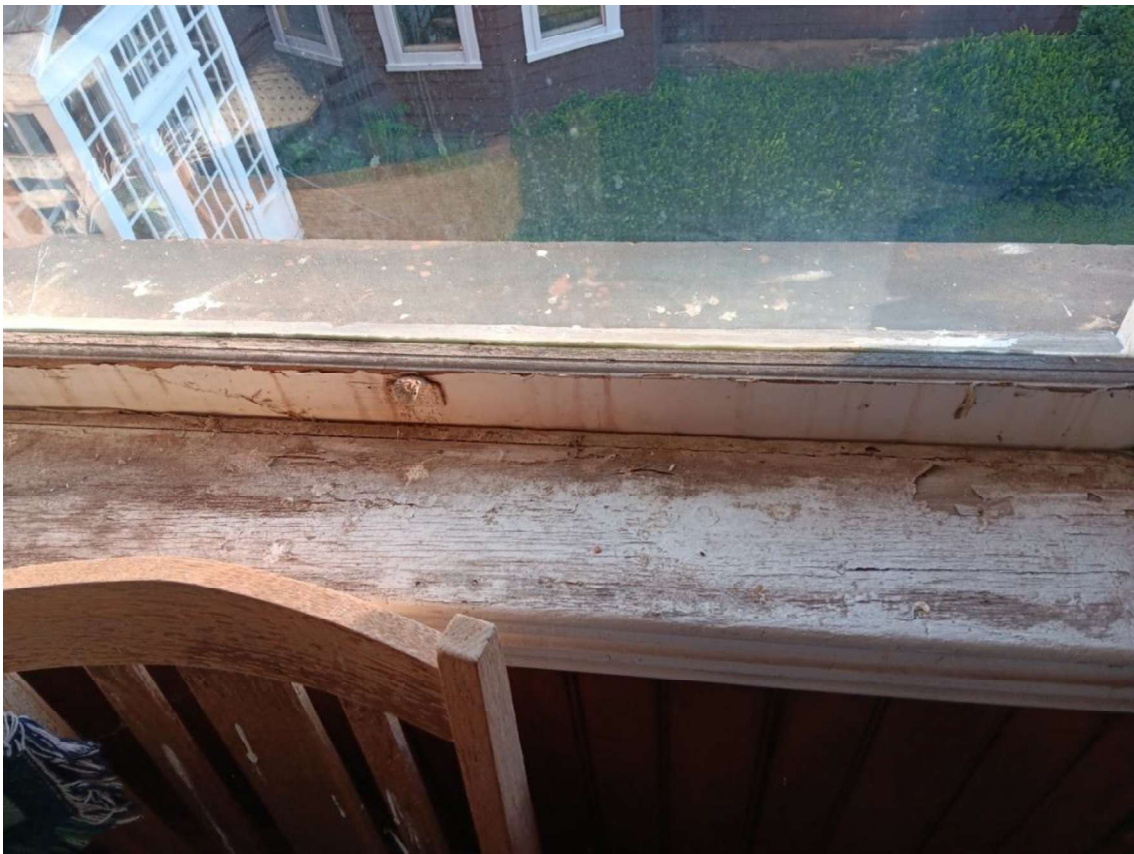
Typical double hung window

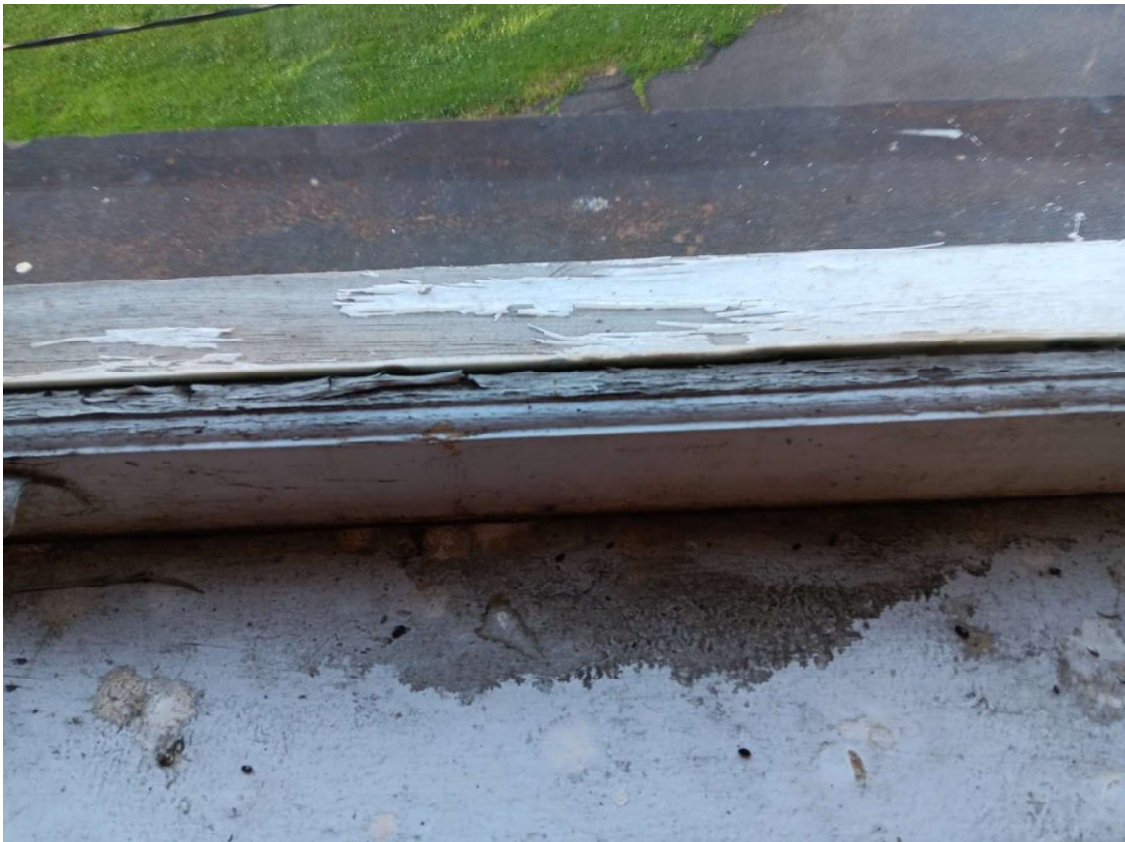
Typical double hung window

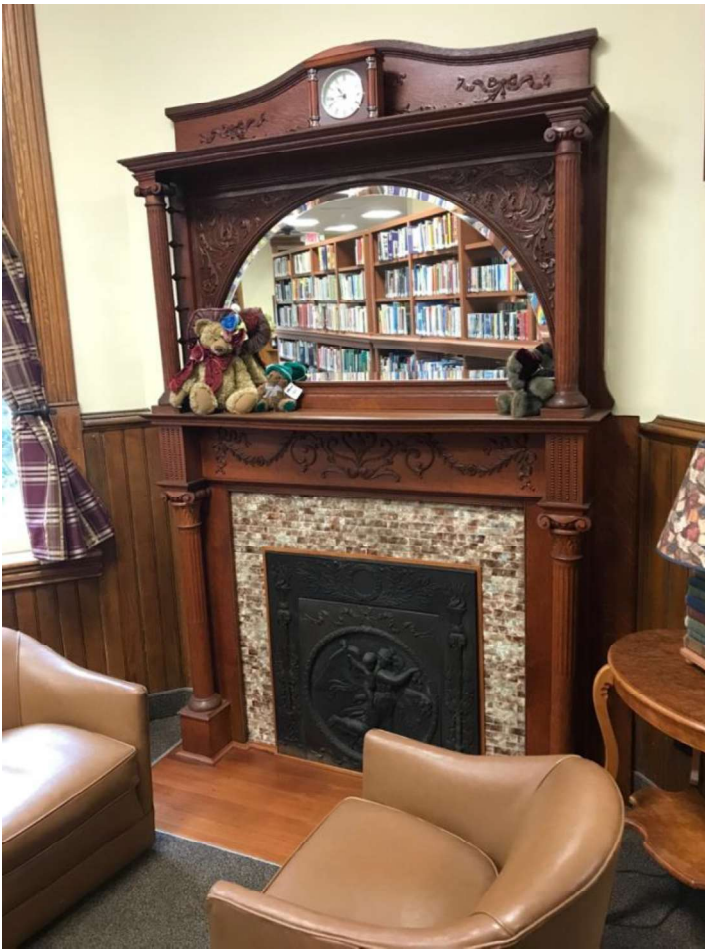
Original Fireplace

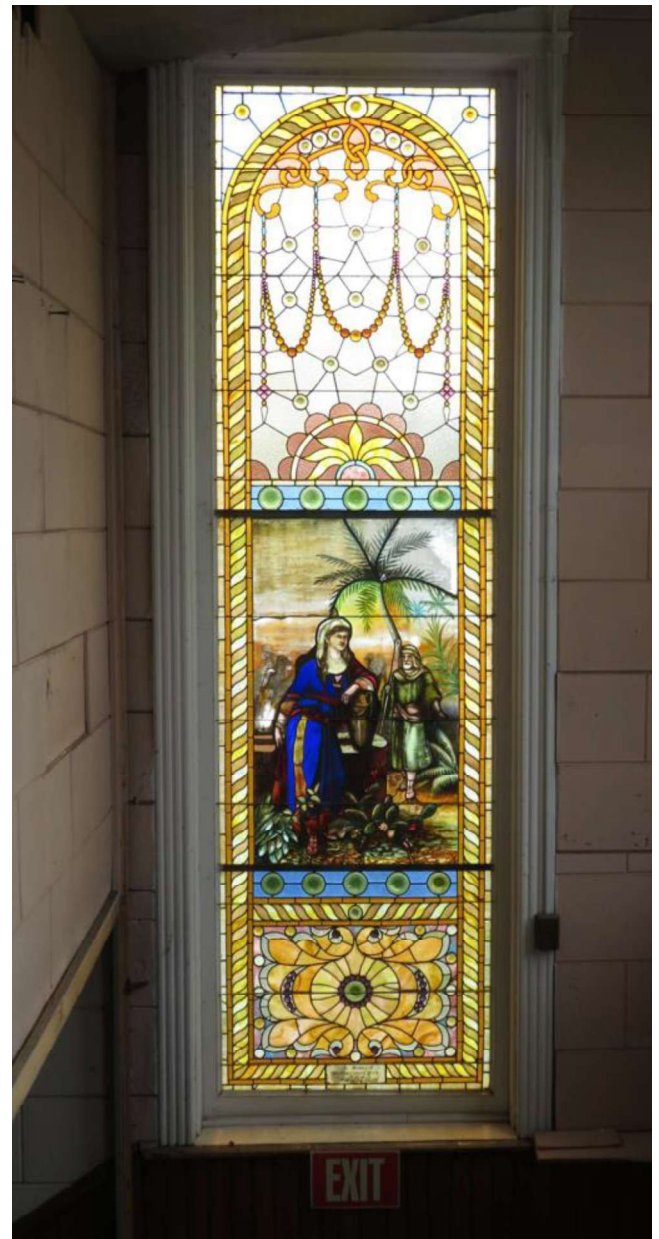
Stained glass "Peck Memorial Window"  
Threatened by unventilated storm panel

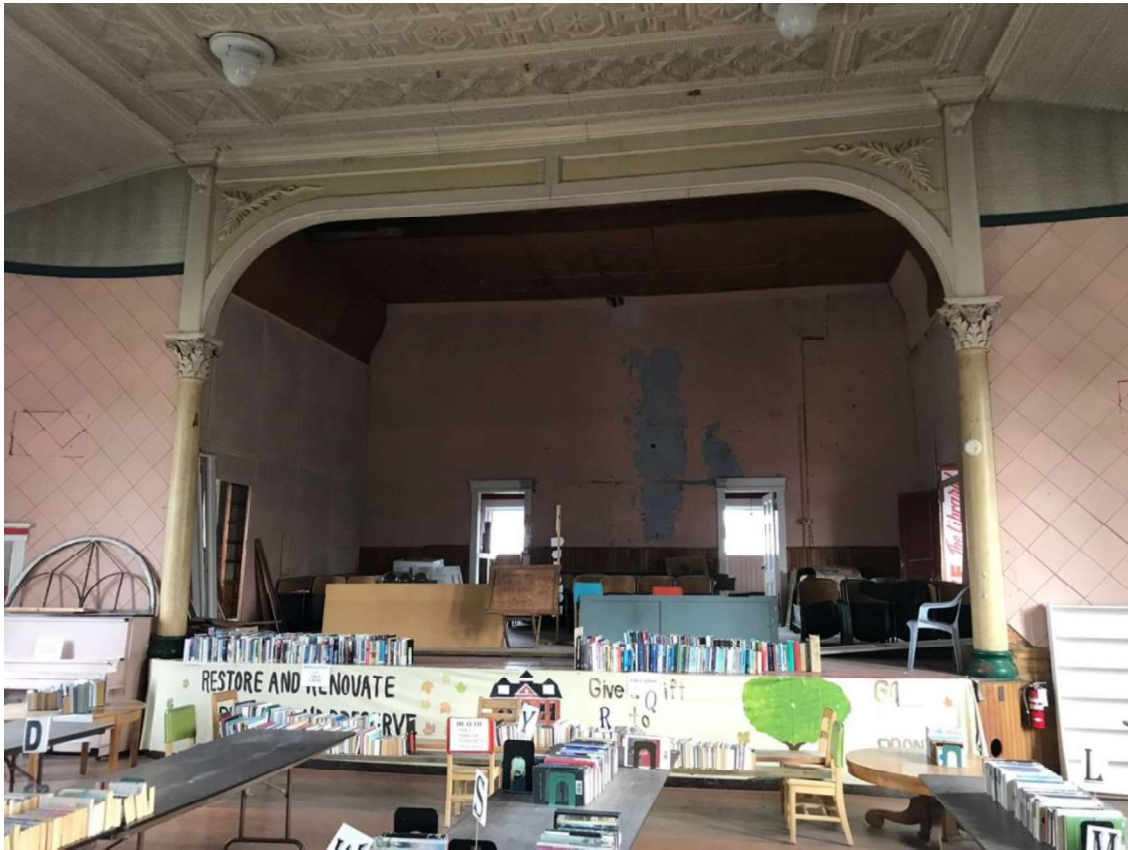
Second floor Opera House proposed for future renovation/restoration

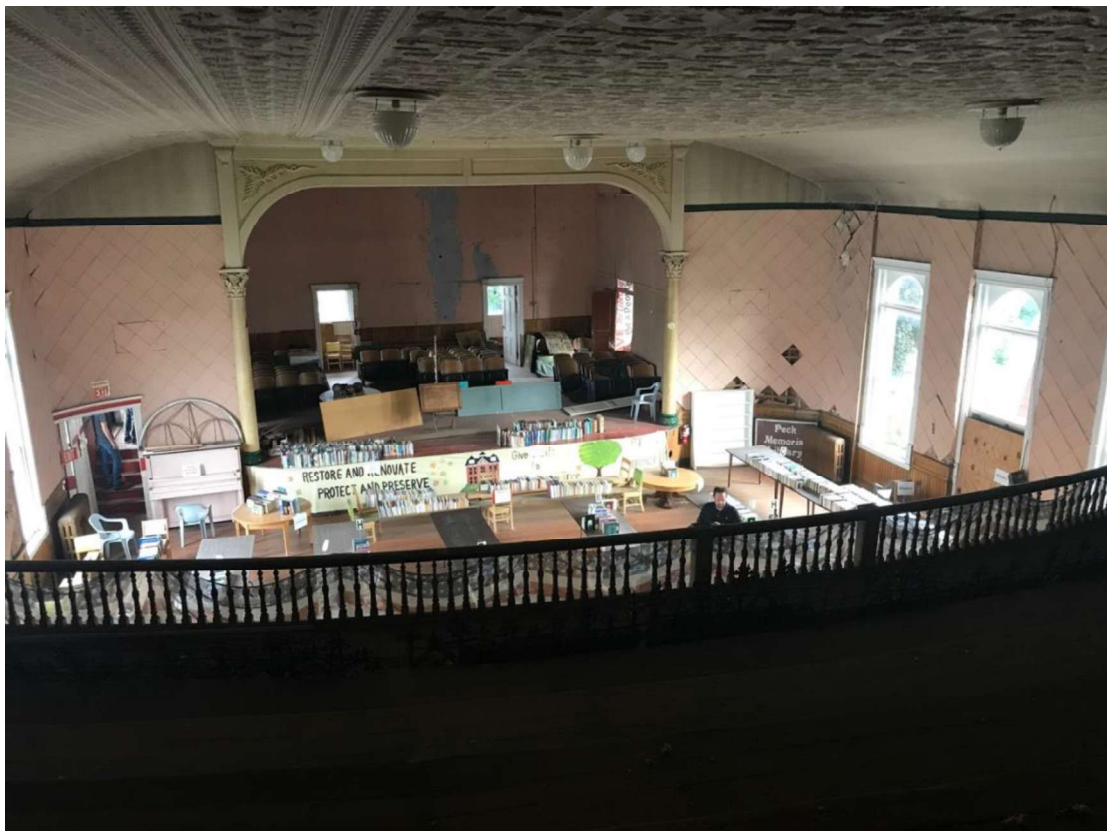
Opera House as seen from balcony
