# LIMITED BUILDING SURVEY FOR ASBESTOS CONTAINING MATERIALS

**Subject Property:** Peck Memorial Library

**Address:** 24 East Main Street  
Marathon, New York

**Date of Survey:** August 15, 2025

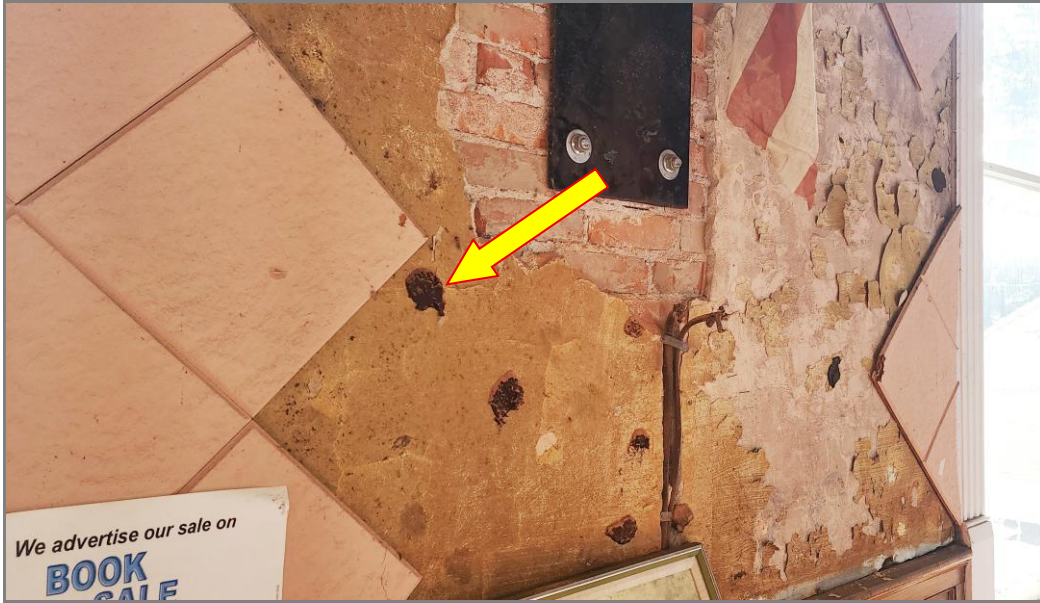
Photo 1:

- **Non-friable light brown and dark brown mastic adhesive pucks** behind fiberboard wall tiles on the second floor (approximately 2,000 square feet of wall tiles observed).

Light and dark brown mastic pucks behind fiberboard tiles on second floor walls are positive non-friable ACM.

Prior to demolition or disturbance, asbestos containing materials should be removed in accordance with 12NYCRR Part 56.

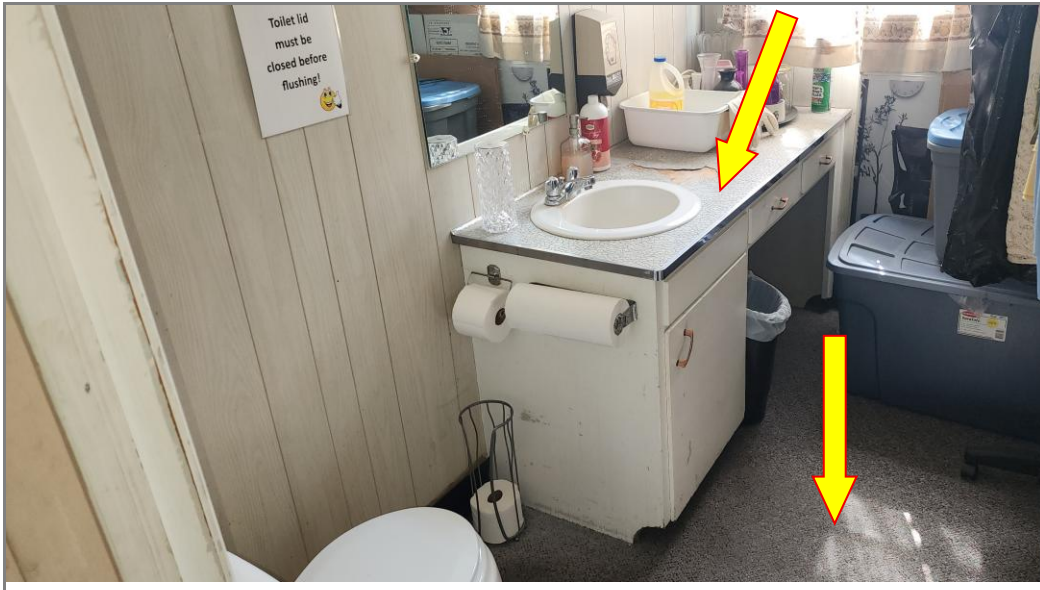
Photo 2:

Blue 9x9 resilient tiles with thin inseparable mastic and in the first floor southeast restroom are positive non-friable ACM.

These tiles are located on the restroom countertop as well as beneath carpet on the floor

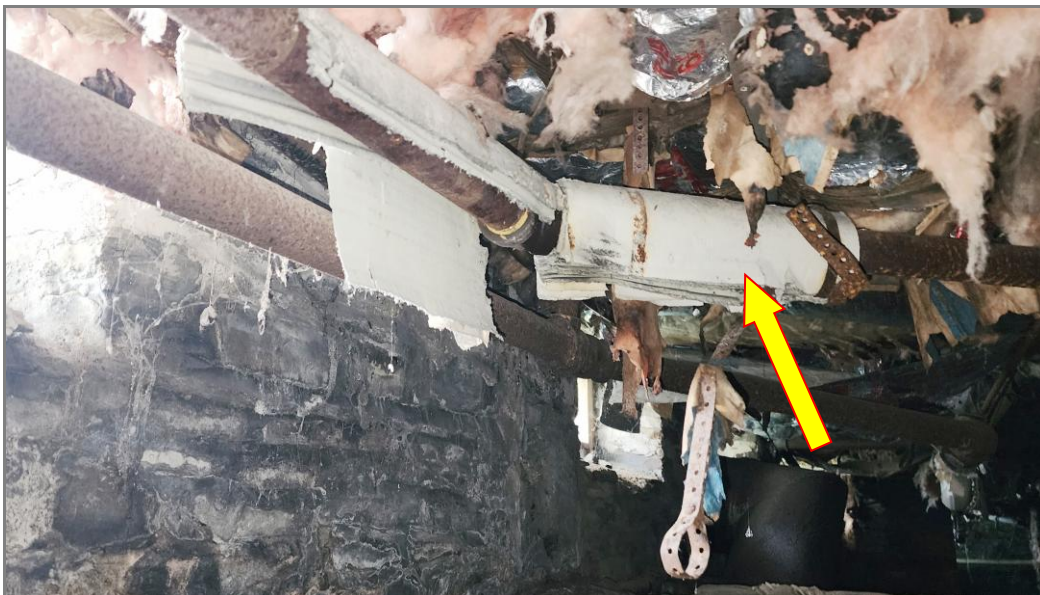
Photo 3:

- **Friable aircell and remnant fitting thermal system insulation** on pipes in the basement (approximately 90 linear feet observed on pipes; additional TSI may exist in hidden cavities within the structure).

Aircell pipe insulation on pipes in the basement is positive friable ACM.

Much of this material is damaged.

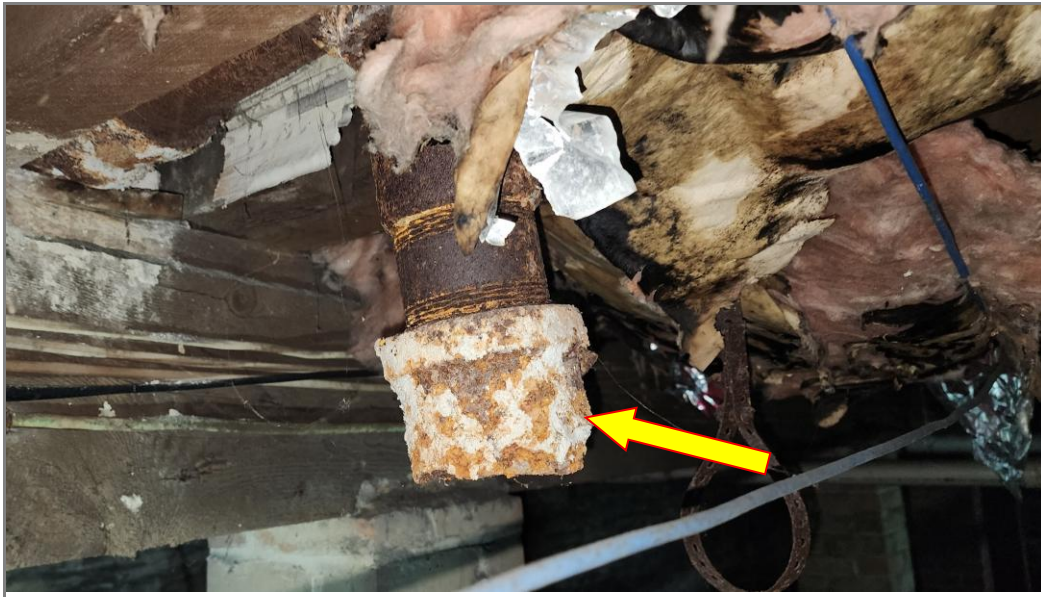
Photo 4:

Remnant fitting insulation on basement pipe fittings is positive friable ACM.

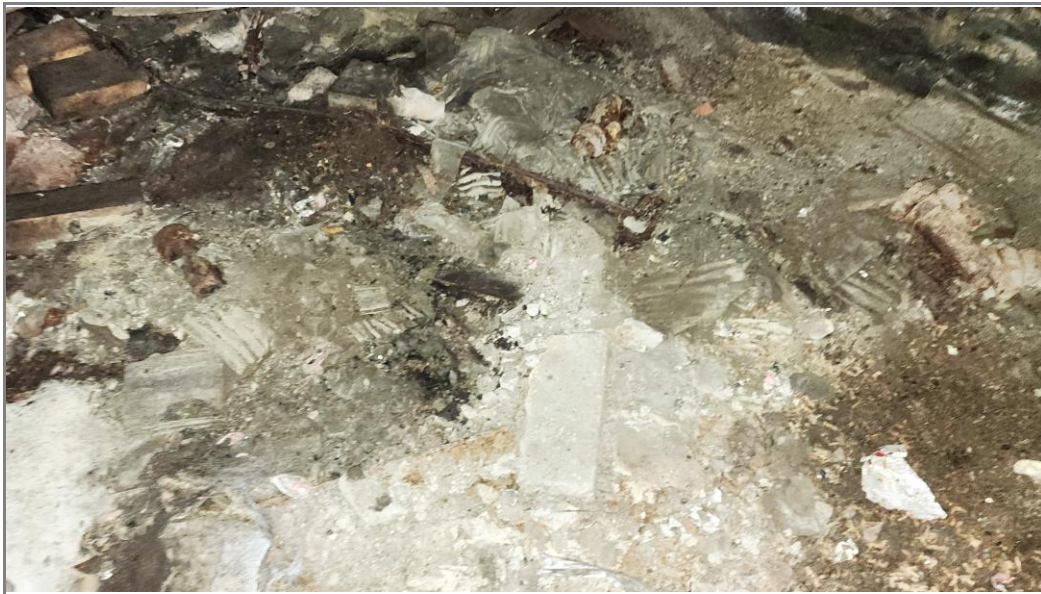
Photo 5:

Some of this insulation is damaged, and broken pieces and debris were observed across much of the basement dirt floor. Due to the widespread nature of this condition, the entire basement floor is considered an incidental disturbance per 12NYCRR Part 56.

Damaged pipe insulation debris was observed in multiple areas across much of the basement dirt floor.

This condition constitutes an incidental disturbance per 12NYCRR Part 56.

As per requirements of 12NYCRR Part 56, the area of the incidental disturbance should be delineated with barrier tape and signage posted as described in 12NYCRR Part 56 Section 11.2. Additionally, the affected area should be isolated to avoid additional contamination. Prior to the commencement of an asbestos project, which is necessary to respond to the cleanup of the incidental disturbance, the asbestos abatement contractor shall contact the Asbestos Control Bureau to request permission to proceed with the cleanup.

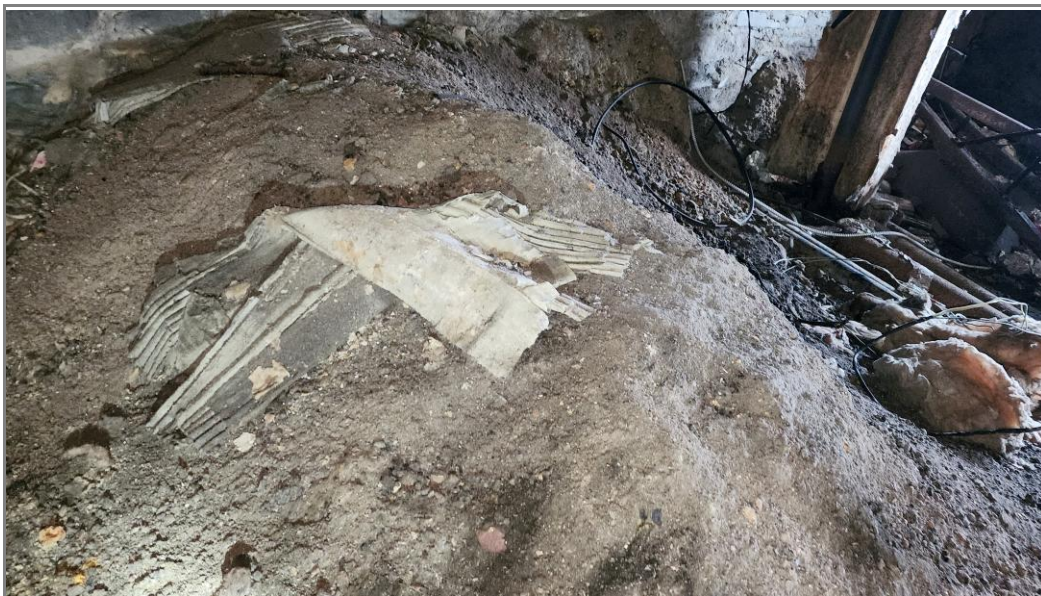
Photo 6:

Damaged pipe insulation debris was observed in multiple areas across much of the basement dirt floor.

This condition constitutes an incidental disturbance per 12NYCRR Part 56.
