# LIMITED BUILDING SURVEY FOR ASBESTOS CONTAINING MATERIALS

**Subject Property:** Peck Memorial Library

**Address:** 24 East Main Street  
Marathon, New York

**Date of Survey:** August 15, 2025

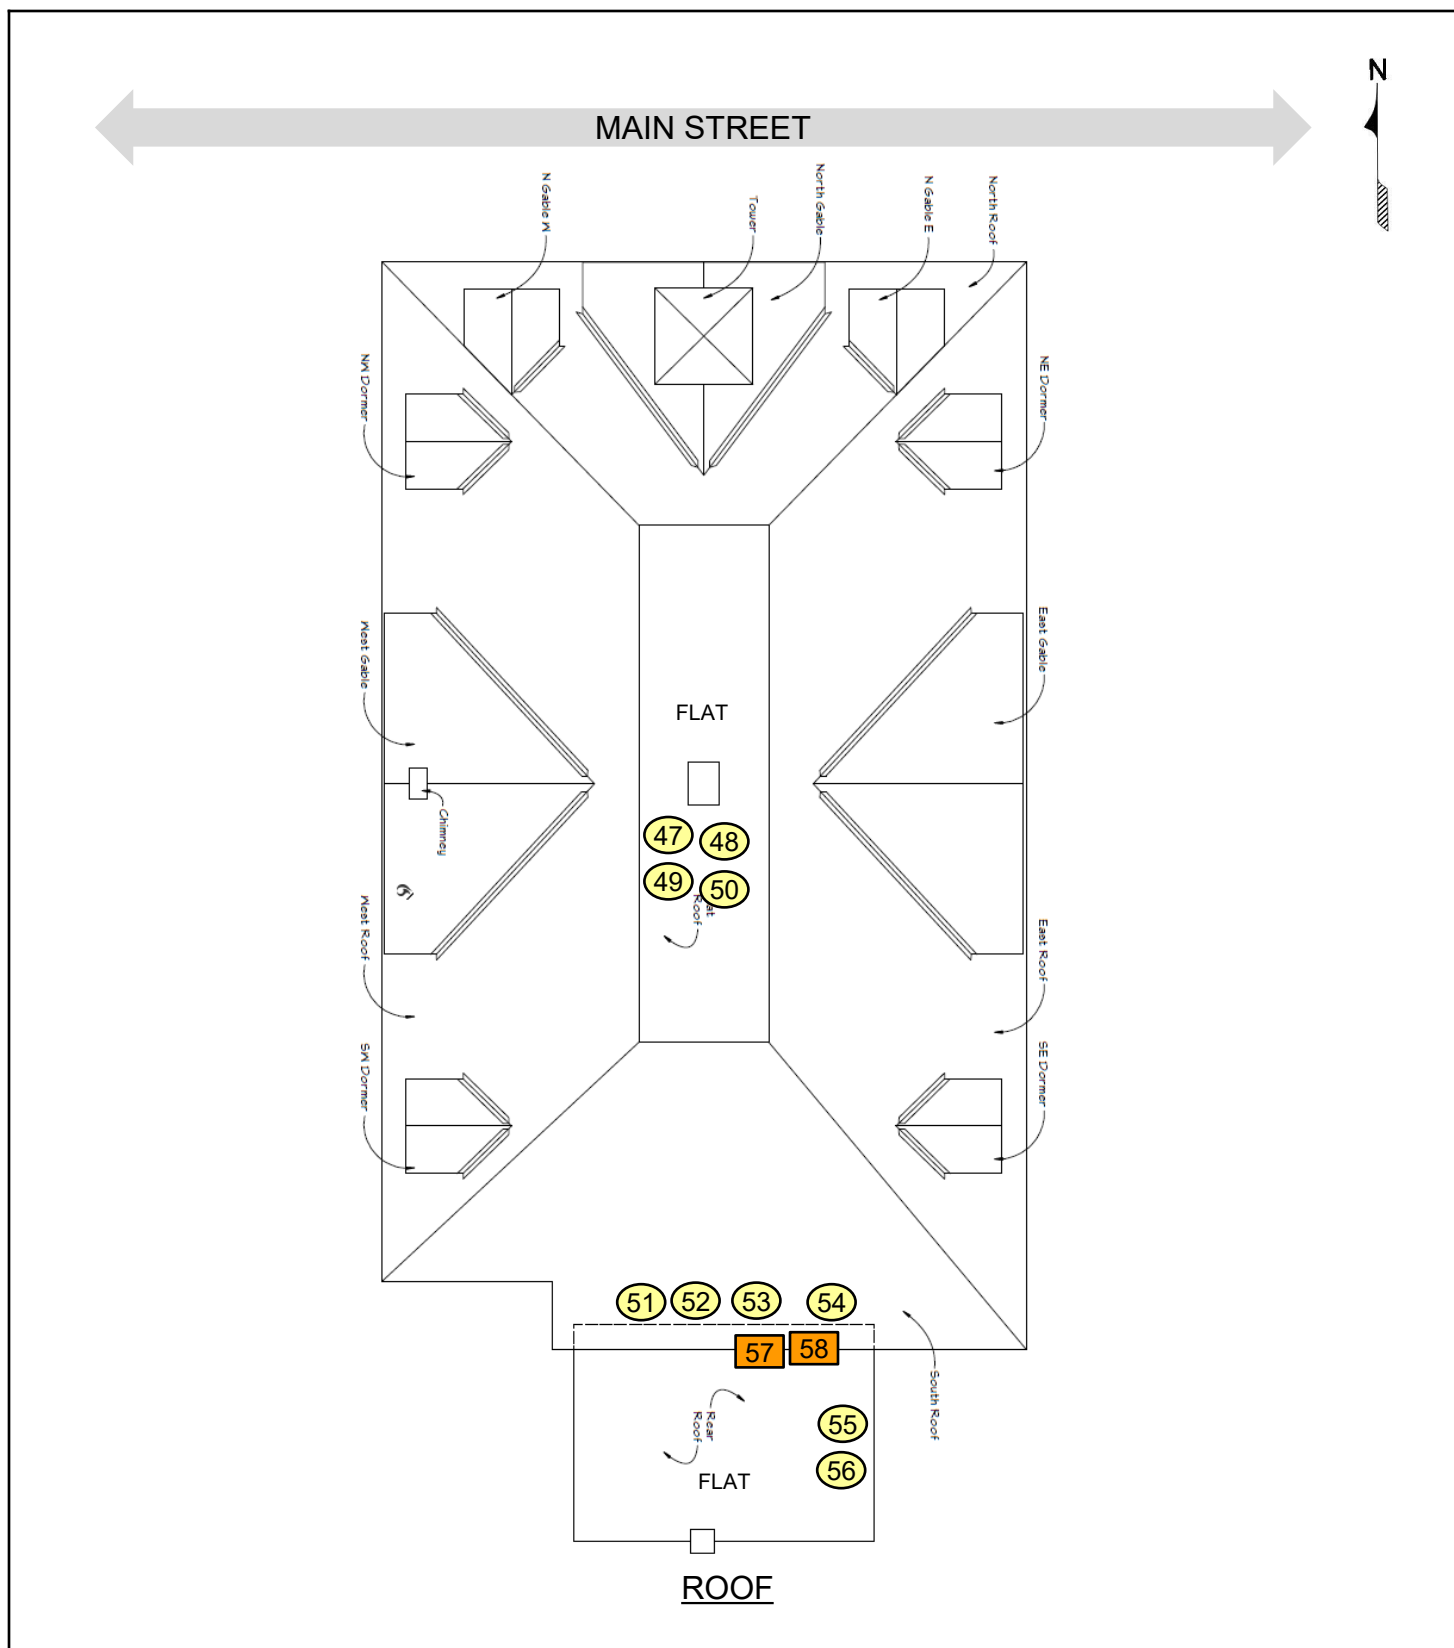
**FIGURE 2: BUILDING AND SAMPLING DIAGRAM**

Diagrams of the building showing locations of positive and negative samples are presented in **Figure 2**.

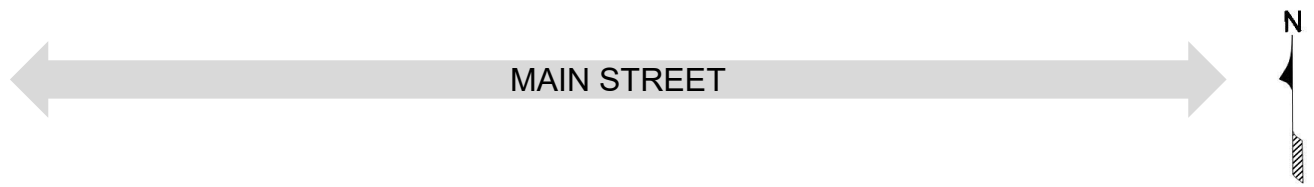
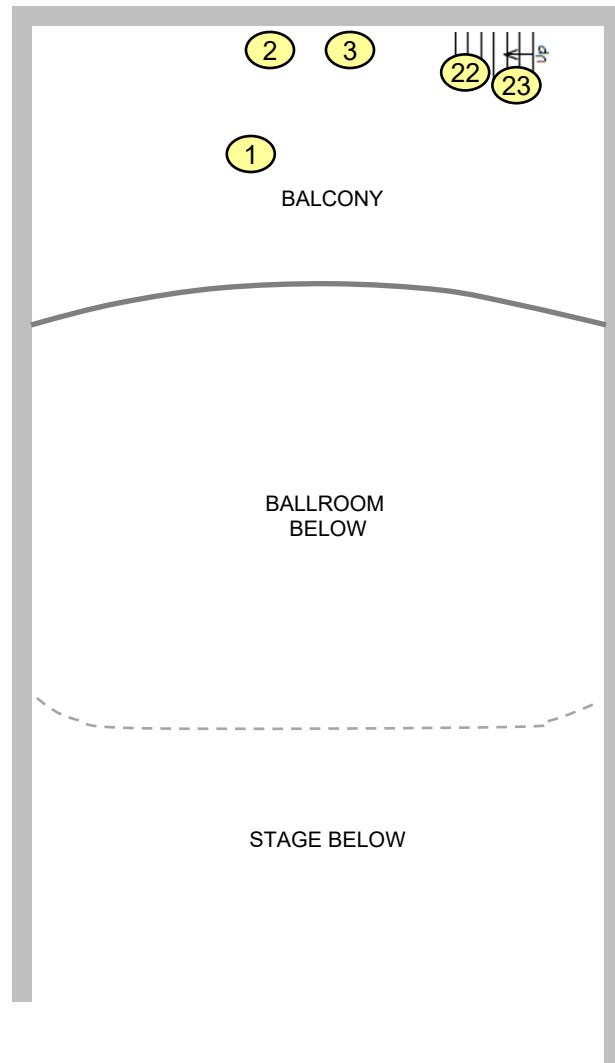
3<sup>RD</sup> FLOOR BALCONY

| Date | Lakeland Sample # | Layer | Diagram location number | Building area | Location (refer to diagrams) | Suspect material | Friability | Condition of Friable ACM | H.A. | Estimated Quantity of Homogeneous ACM | % asbestos |
|---|---|---|---|---|---|---|---|---|---|---|---|
| 8/15/25 | H1525-101 | n/a | 1 | 3FL | Balcony | White loose fill insulation | Friable | n/a | A | n/a | NAD |
